The performance of modular block walls reinforced with geogrid subject strong ground motions during the 2016 Kaikoura earthquake

ABSTRACT: The existing Dashwood Bridge on State Highway 1 over the railway line was a pinch point and quite dangerous with the high number of trucks using it. The bridge was built in 1932 in a continuous 4 span concrete beam, and no longer met the NZTA seismic standards. It was decided, due to the strategic route strategy risk, that a new structure was required with improved alignment across the railway. One of the main design considerations was the seismic load case (acceleration specified was 0.6g), because the structure is located only 12km from a large earthquake of $M_w = 6.5$ which occurred on 21st August 2013 (17km depth, and 20km east of Seddon). The 70-week project was started in January 2014 and the Keystone TW3 walls were started at the end of June 2014 taking approximately 1 month to complete the two walls, one at each end of the culvert. The 2016 Kaikoura earthquake occurred at two minutes after midnight on 14th November 2016 in the north eastern part of the South Island of New Zealand, with magnitude $M_w = 7.8$. This resulted in the Keysto

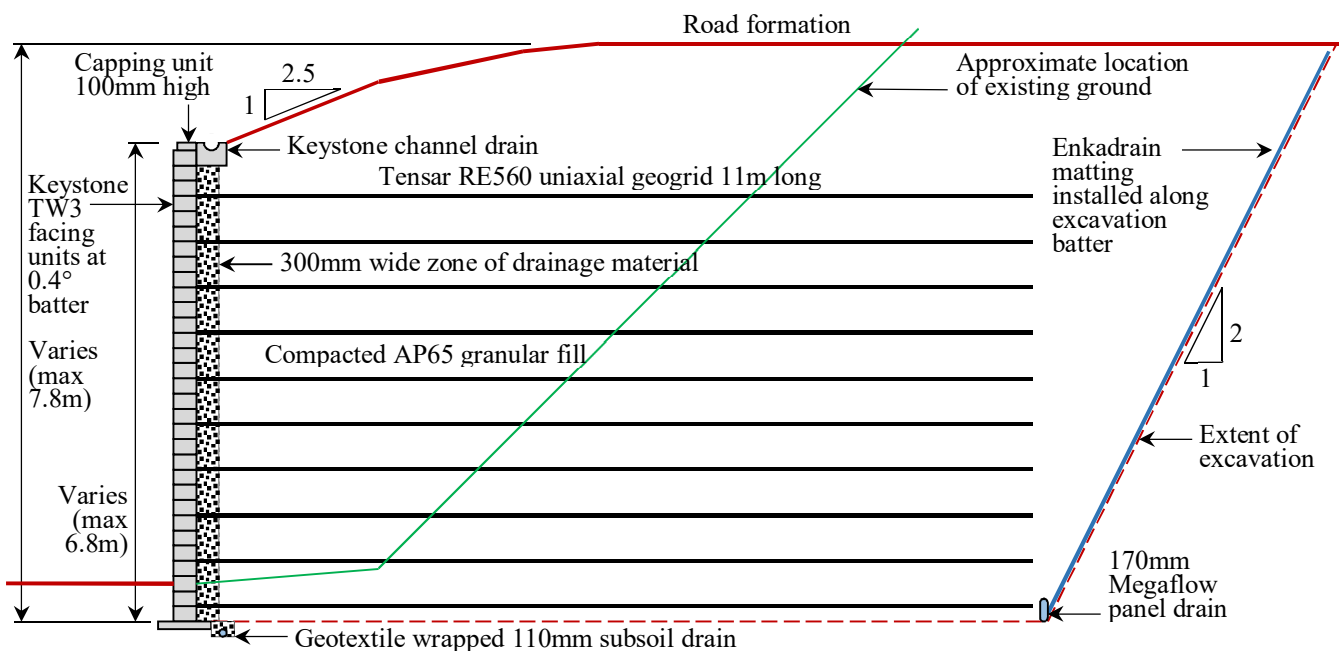
The final layout had a geogrid spacing of 0.6m (every 3rd block) and a reinforcement length of up to 11m to satisfy the stability requirements, see Figure 4.

Figure 4. Keystone TW3 Eastern Wall (based on Opus Drawing 3/35/36/7544/R1)

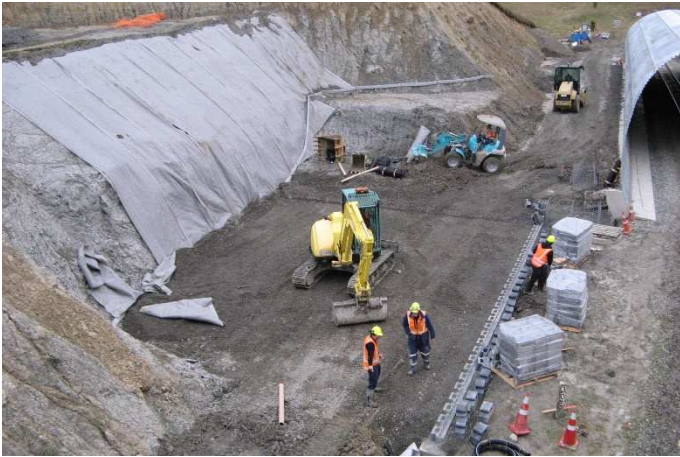
Figure 5. Keystone TW3 east wall at Dashwood at early stage

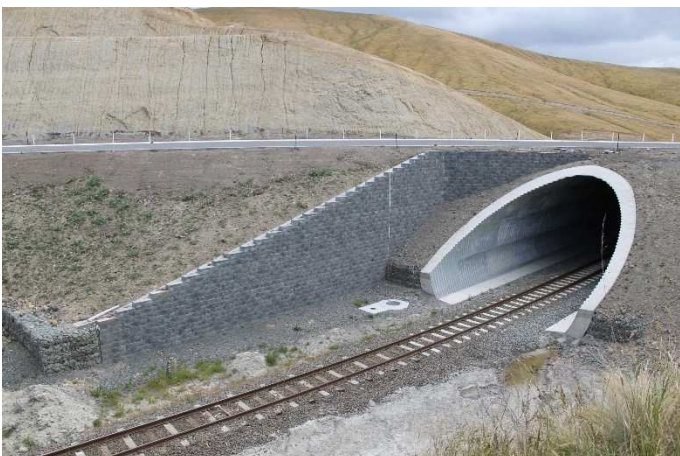
Figure 6. Keystone TW3 west wall at Dashwood completed

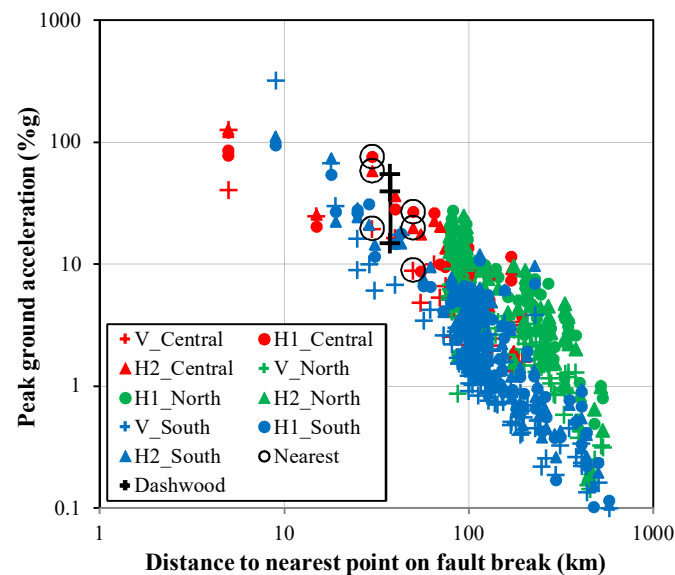
Figure 8. Attenuation of peak ground acceleration with distance from Kaikoura earthquake fault break (Source: ftp.geonet.org.nz)

Based on these adjustments, the distance axis on Figure 8 is referred to as the “distance to nearest point on fault break” in km. Also, on Figure 8, the large black open circular symbols highlight the recordings from the two stations (SEDS and MGCS) which were mentioned previously as being closest to the Dashwood retaining walls.

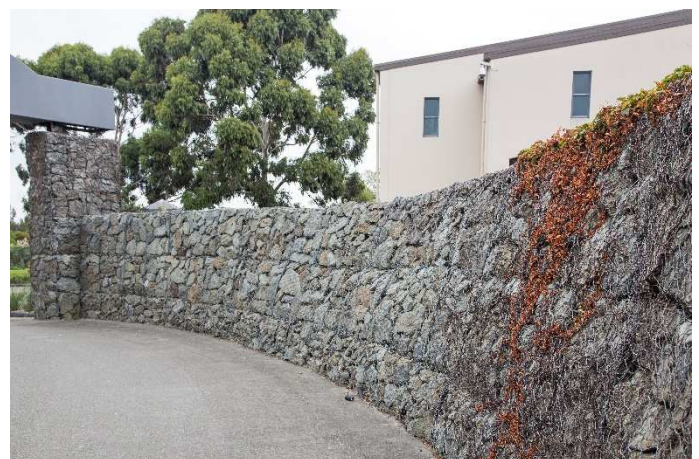
Figure 10. Gabion wall at winery south of Blenheim

A free-standing architectural gabion wall at a winery located 7km south of Blenheim Marlborough Girls College underwent permanent deformation from the earthquake, as shown in Figure 10.

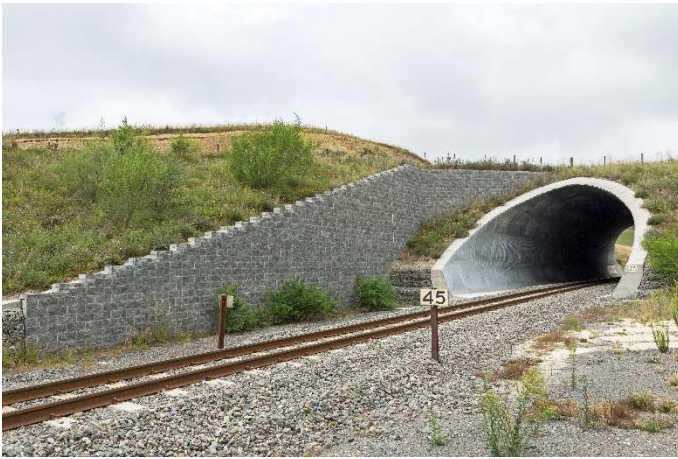
The image below in Figure 11 shows a similar view after the earthquake as the “before” photo in Figure 6.

Figure 11. Keystone TW3 western wall in early 2018

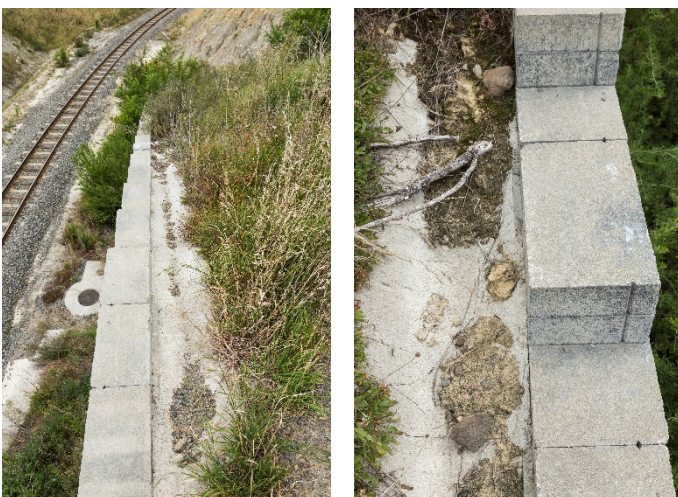
Figure 12. Views of swale drains

The inspection of the walls showed no sign of movement both vertically outwards and in horizontal alignment. The clearest evidence is shown by the images

in Figure 12 of the swale drains. There is no separation of the swale drain from the top of the wall and no observed cracks in the fill above the wall.

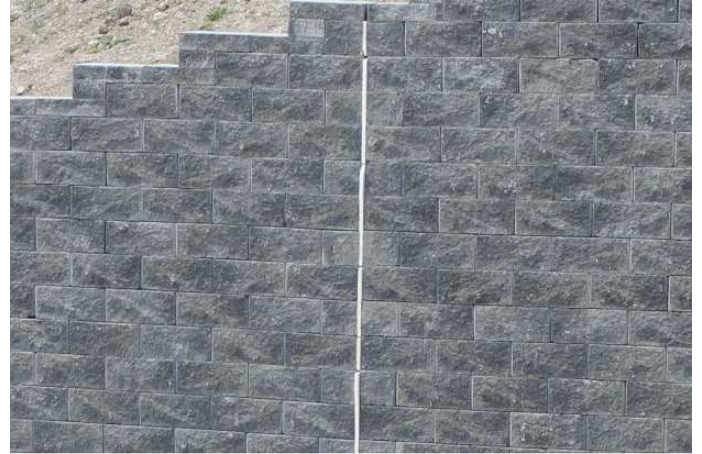
A slip joint was designed into the wall to accommodate differential settlement at the transition where the wall extends up the sides of the culvert at an angle. There has been some minor relative movement of the upslope section (<10mm) however it is unknown if this had occurred as a result of the earthquake shaking or under normal loading conditions. Figures 13 and 14 show the slip joint both pre- and post-earthquake.

Figure 13. Slip joint pre-earthquake

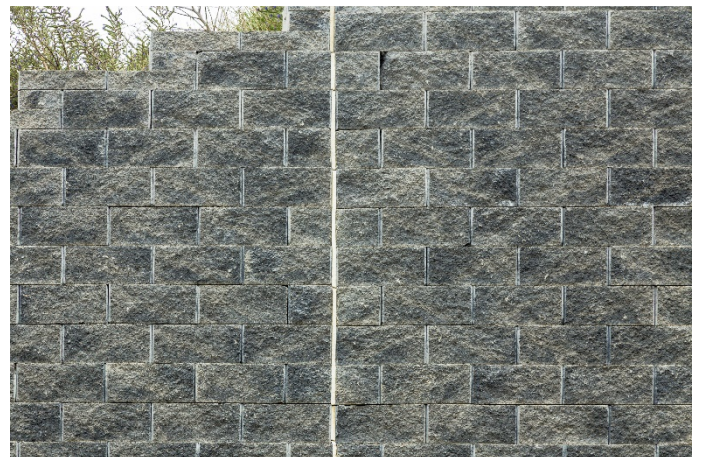
Figure 14. Slip joint post-earthquake

It is clear from these photos that the walls have performed extremely well during the strong shaking which took place during the Kaikoura earthquake with no signs of distress.

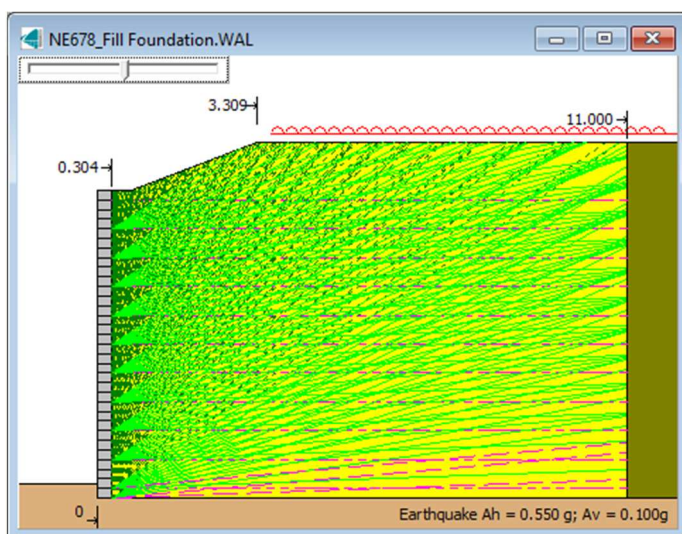
The results of this investigation are shown in Figure 15, which shows all wedges (lower boundaries of each Wedge 2 as defined in Figure 3) crossing the reinforced soil mass as coloured lines. Green lines have adequate margin against failure, and red or pink lines indicate cases where factored resisting force is less than factored driving force. There are five very low angle wedges with a pink colour near the base of the structure indicating the critical mechanisms which first appear at $K_v = 0.1g$. The appearance of these wedges at very low angles at the base of the reinforced soil mass is the normal critical behaviour expected in a case of very strong seismic shaking. In this analysis, K_v is applied both upwards and downwards, and these critical mechanisms are for the case of K_v upwards, which is also the normal case.

Although unsatisfactory, the pink wedges below would not necessarily indicate a failure condition, but rather a condition where factored resisting forces are less than factored driving forces. This confirms the satisfactory initial design for the Dashwood walls, as well as the importance of considering the effects of vertical acceleration in the design of reinforced soil structures. In this case, the vector acceleration of $K_h = 0.55g$ and $K_v = 0.1g$ is 0.56g with an upward inclination of 10 degrees. This is a seismic loading situation which should be considered and investigated as part of the seismic design of a reinforced structure.

Figure 15. Back-analysis of internal stability
